## **DESTRUCTIVE EVALUATION AND EXTENDED FATIGUE TESTING OF RETIRED AIRCRAFT FUSELAGE STRUCTURE: PROJECT UPDATE**

**John G. Bakuckas, Jr.**  
**Materials and Structures Branch, AAR-450**  
**FAA William J. Hughes Technical Center**  
**Atlantic City International Airport, NJ 08405, USA**

### **Abstract**

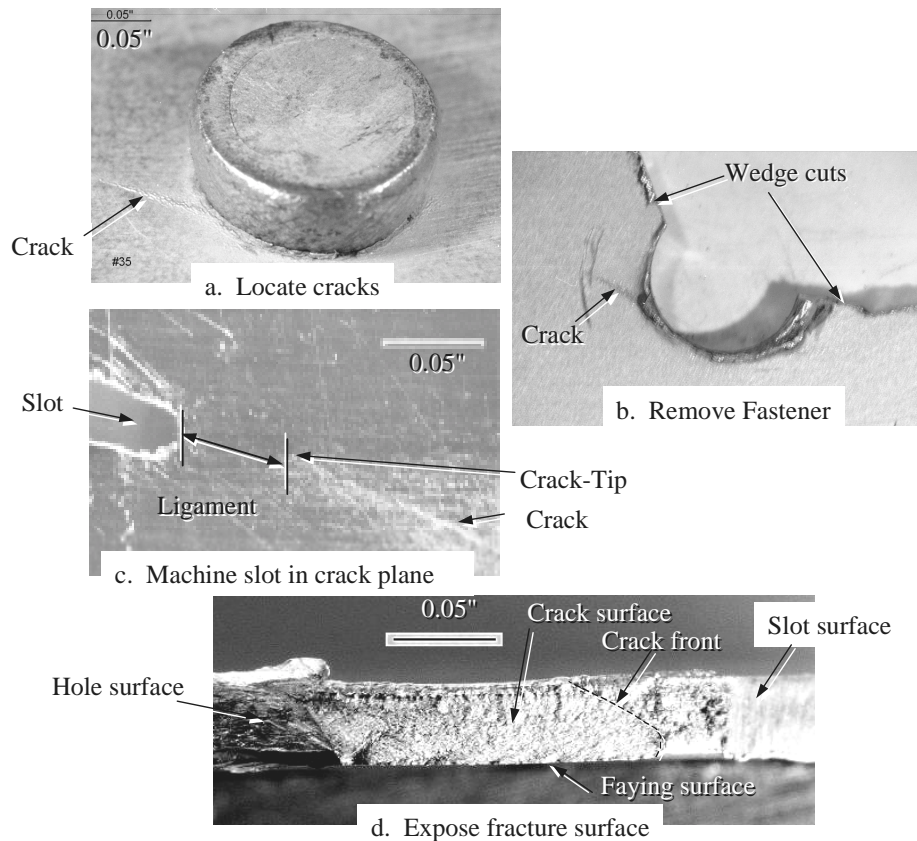
Figure 8. Steps in teardown procedure

A teardown procedure was developed to disassemble joints and reveal fracture surfaces at fasteners as follows, Figure 8:

- Cut 1" square pieces with fasteners in the center from the joint
- Determine location of cracks around the hole via stereo microscopy, Figure 8a
- Identify region around base of fastener that can be removed without destroying cracks
- Machine two cuts through fastener-hole interface and remove fastener, Figure 8b
- Soak sample in D-limonene to soften sealant and pry open layers
- Cut slot in the plane of the crack leaving 0.05" ligament to the crack tip, Figure 8c
- Cool sample using liquid nitrogen
- Break ligament to expose fracture surface of crack, Figure 8d

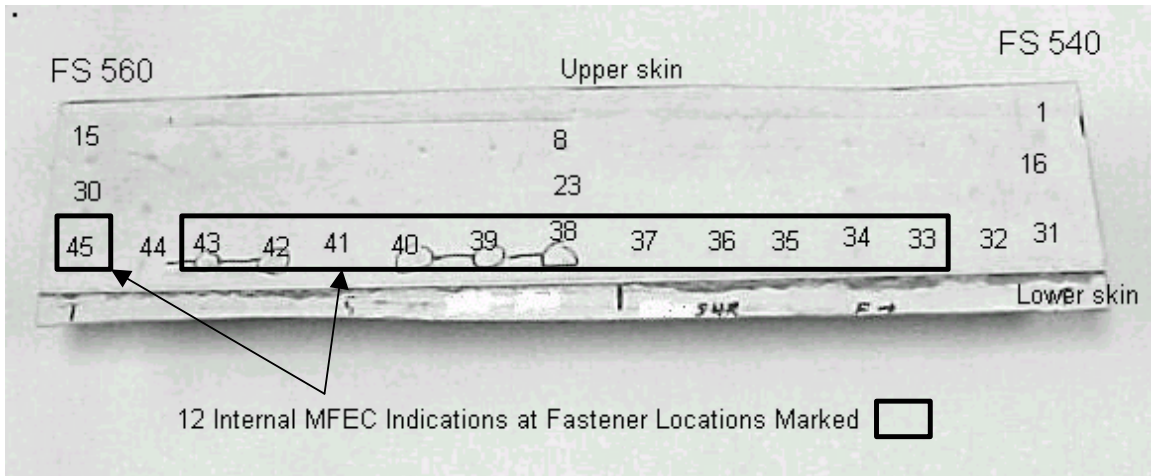
Figure 9. Lap joint section evaluated along stringer 4R

This teardown procedure was used to characterize a section of the lap joint at stringer S-4R between fuselage stations 540 and 560, Figure 9. This section had 12 MFEC crack indications in the lower skin lower row holes, many of which had detectable cracks. Preliminary findings include the following:

- Several lower skin lower row fastener holes had more than two cracks (some had up to five) emanating from the hole
- Each crack had multiple origins
- The general direction of the cracks were normal to the hoop circumferential direction
- Crack fronts were semi-elliptic in shape with the longer side on the faying surface.
- Cracks ranged in size from 0.01" to 0.2"
- The primary origin of the cracks were at the corner of the hole and the faying surface
- While hole quality was not uniformly good, the defects in the holes were generally in the circumferential direction
- Fracture surfaces appeared to be free of corrosion and any gross mechanical rubbing damage
